# REPORT NO. 96-62

# MODULAR ARTILLERY CHARGE SYSTEM (MACS) PA161E1 CONTAINER REDESIGNED PALLET MIL-STD-1660 TESTS

### U.S. ARMY DEFENSE AMMUNITION CENTER VALIDATION ENGINEERING DIVISION SAVANNA, IL 61074-9639

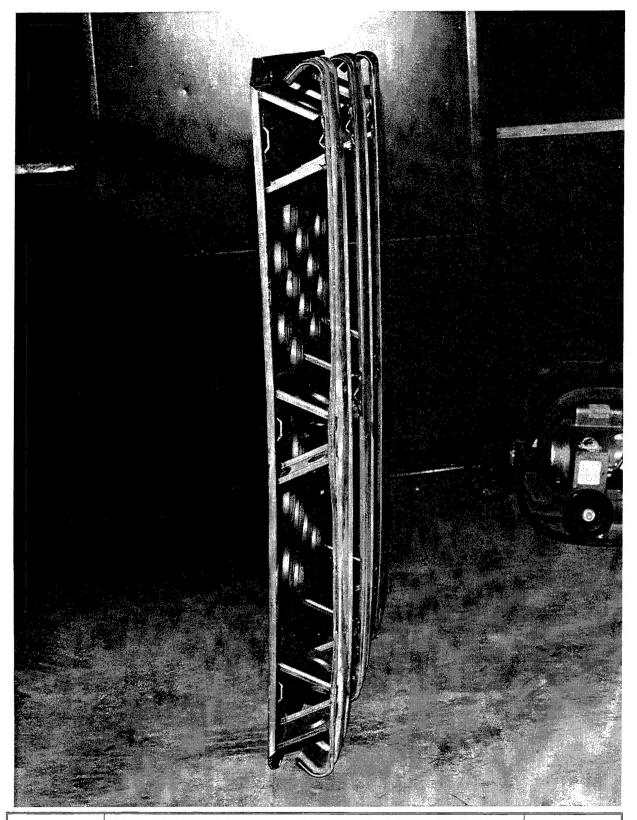
A0317-SCN-96-173-4451. This photo shows the bowed section on the bottom of the pallet.
